## Matthew Jones House

Historic Maintenance and Repair Manual

### **Final report**

Under   Project # 396574, "Matthew Jones House Maintenance & Repair Manual."

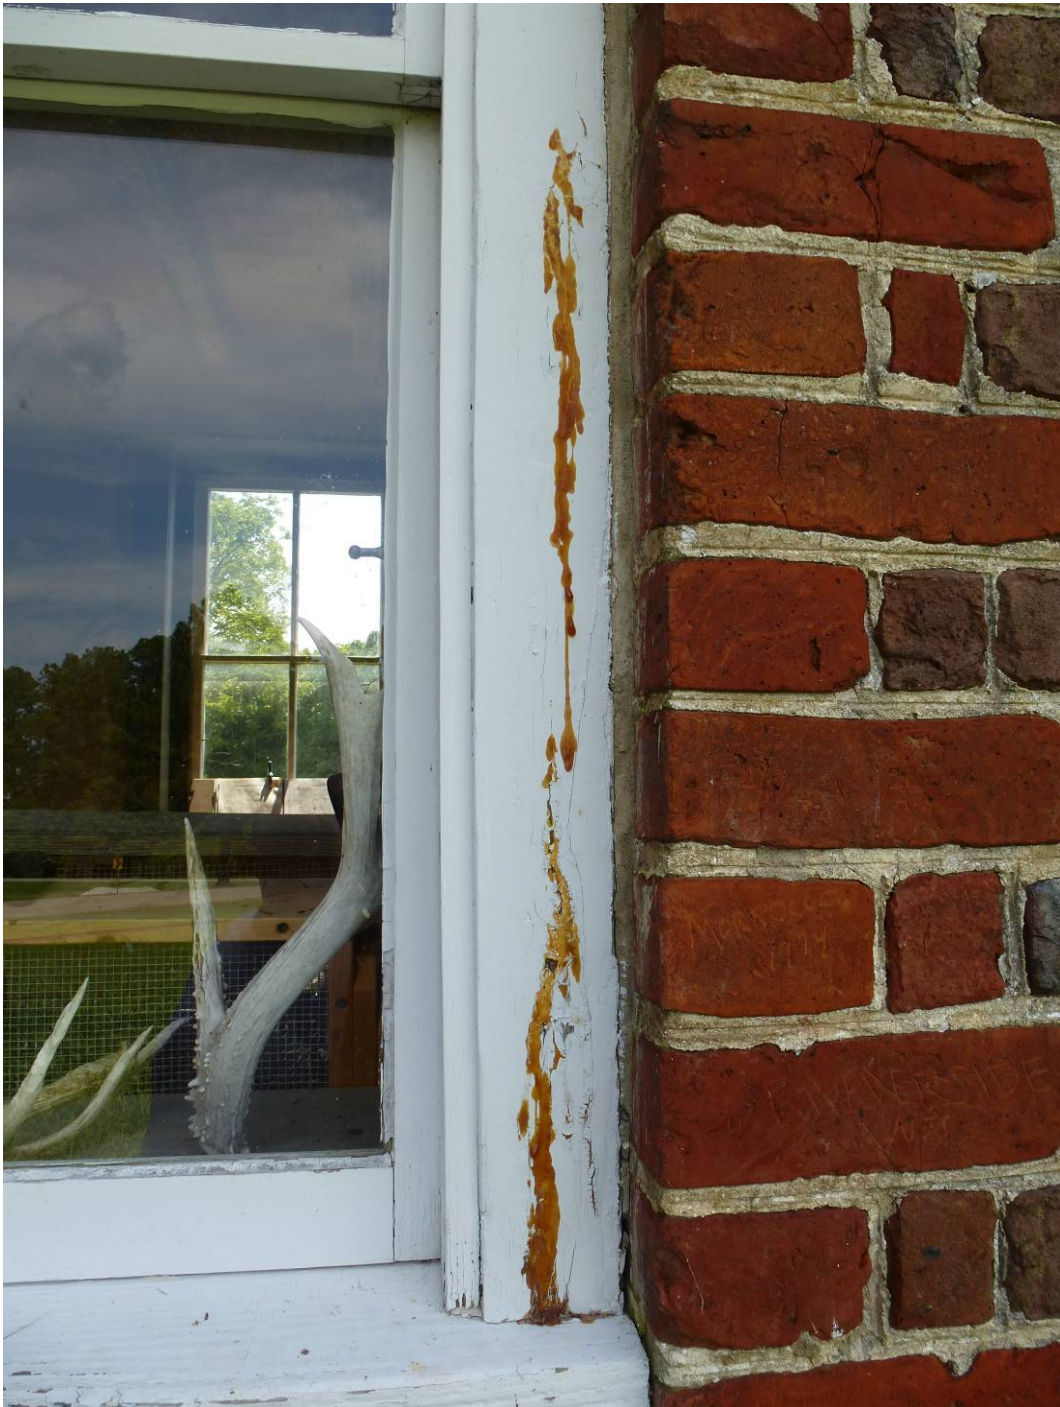
Figure 117. Stains on wood window frame need to be removed (ERDC-CERL, 2012).

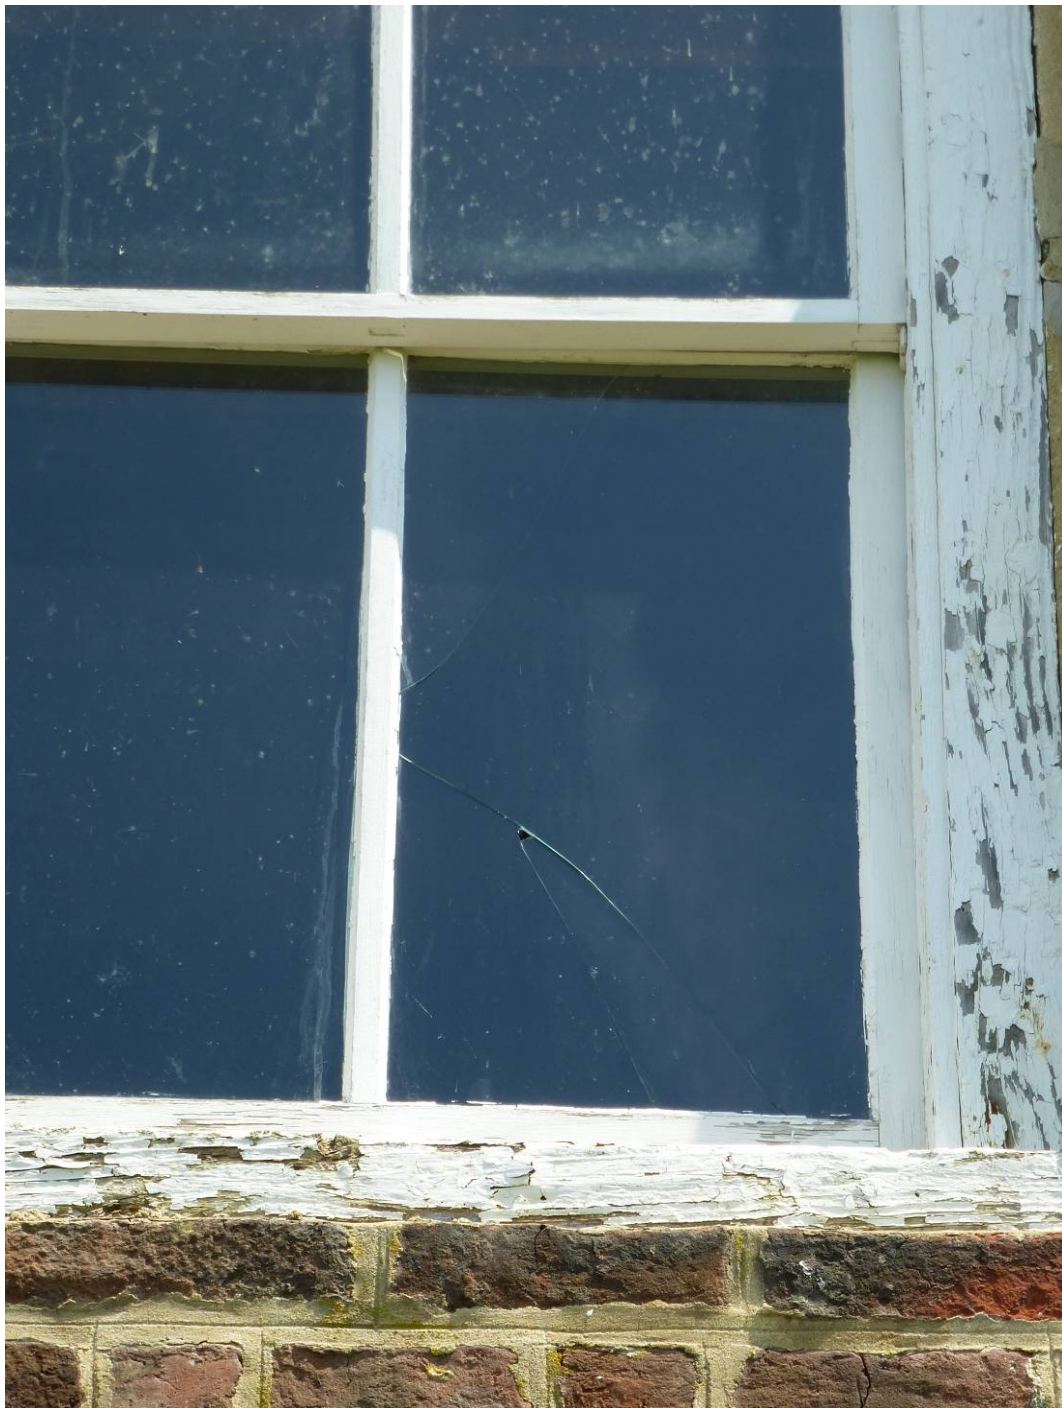
Figure 118. Cracked window pane that even has a hole in it that lets elements into the building (ERDC-CERL, 2012).

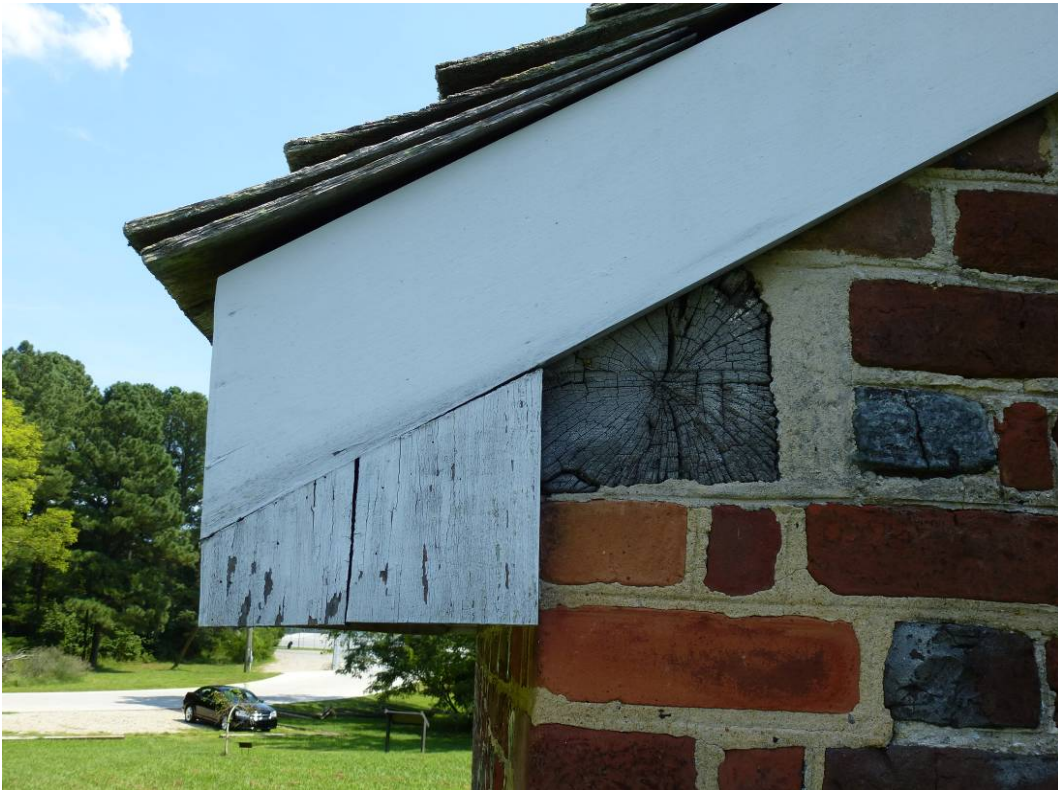
Figure 122. Split wood piece on the shed room (rear chamber) addition (ERDC-CERL, 2012).

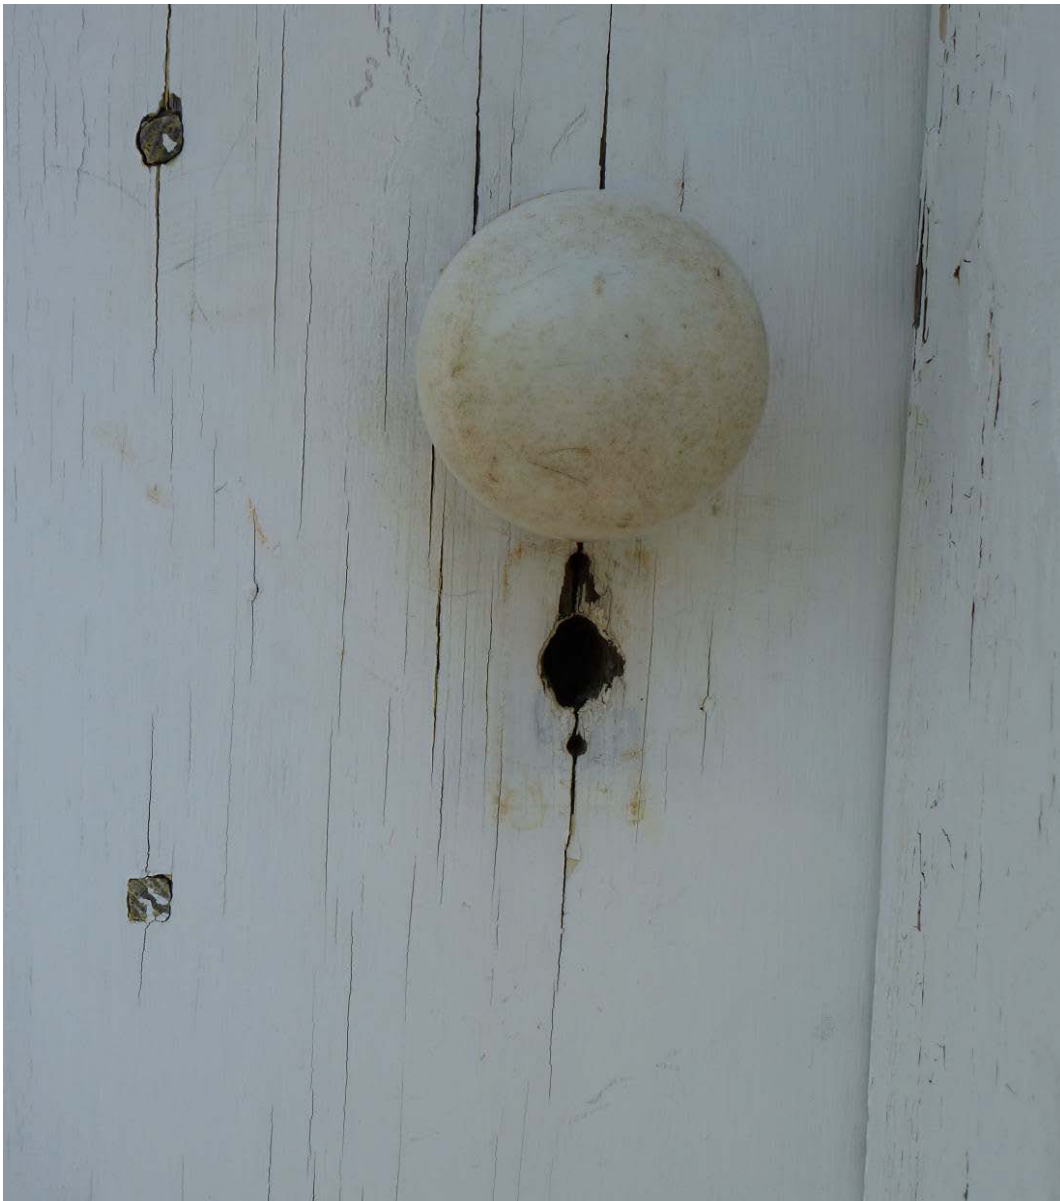
Figure 129. Door knob with missing keyhole on main front door on the southwest elevation (ERDC-CERL, 2012).

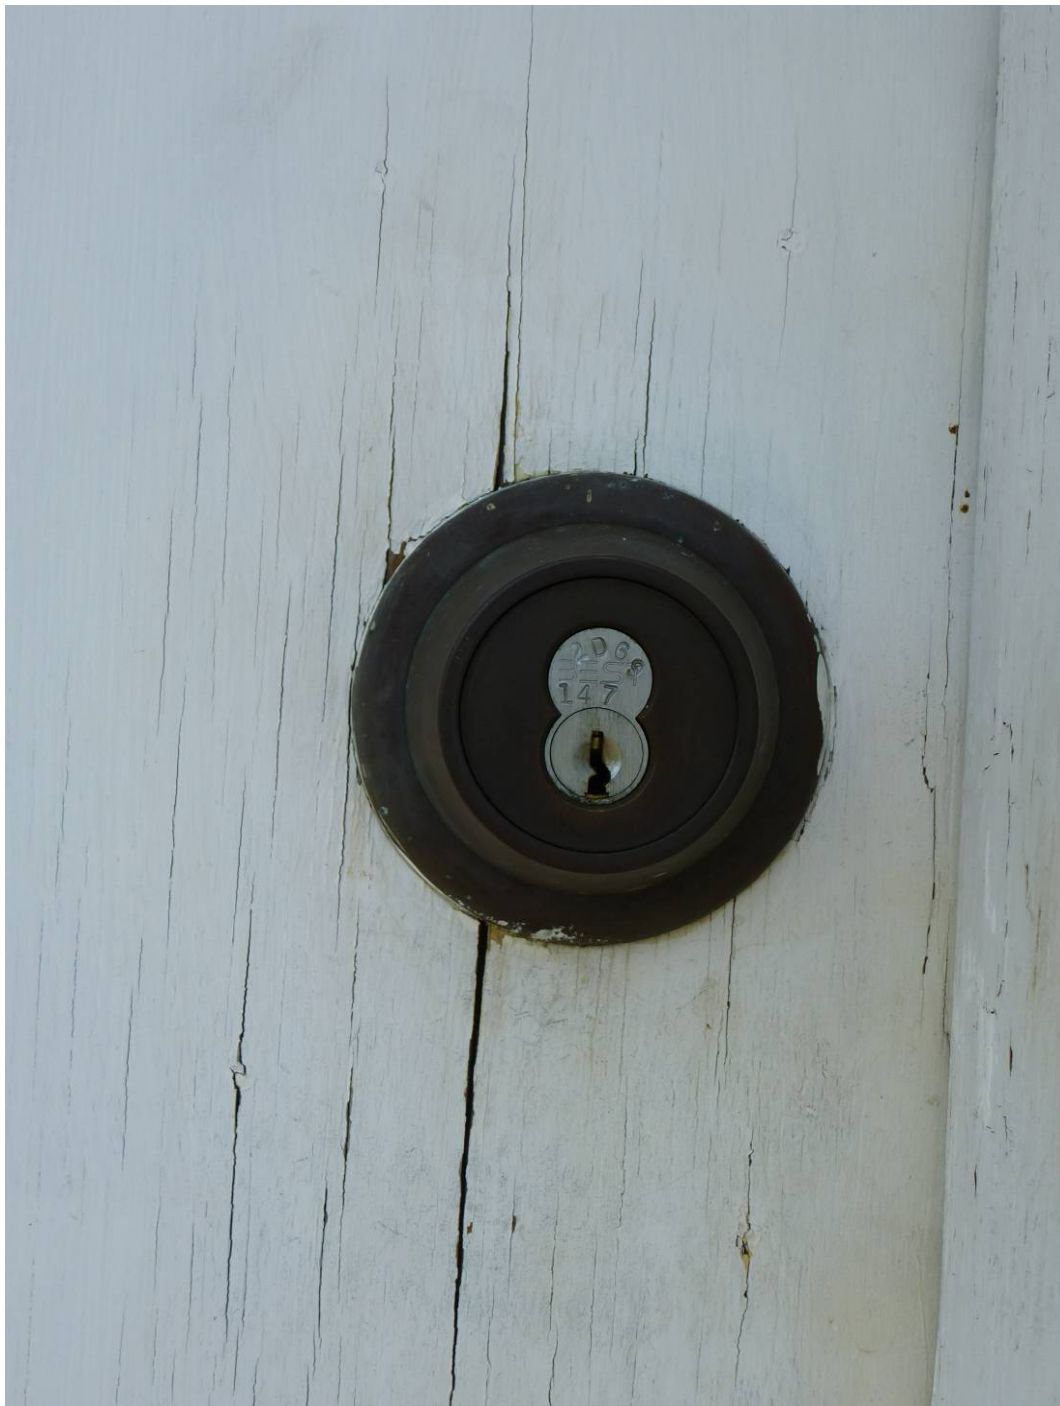
Figure 130. Newer lock added to the front door on the southwest elevation; notice the cracking wood from insertion of the hardware (ERDC-CERL, 2012).

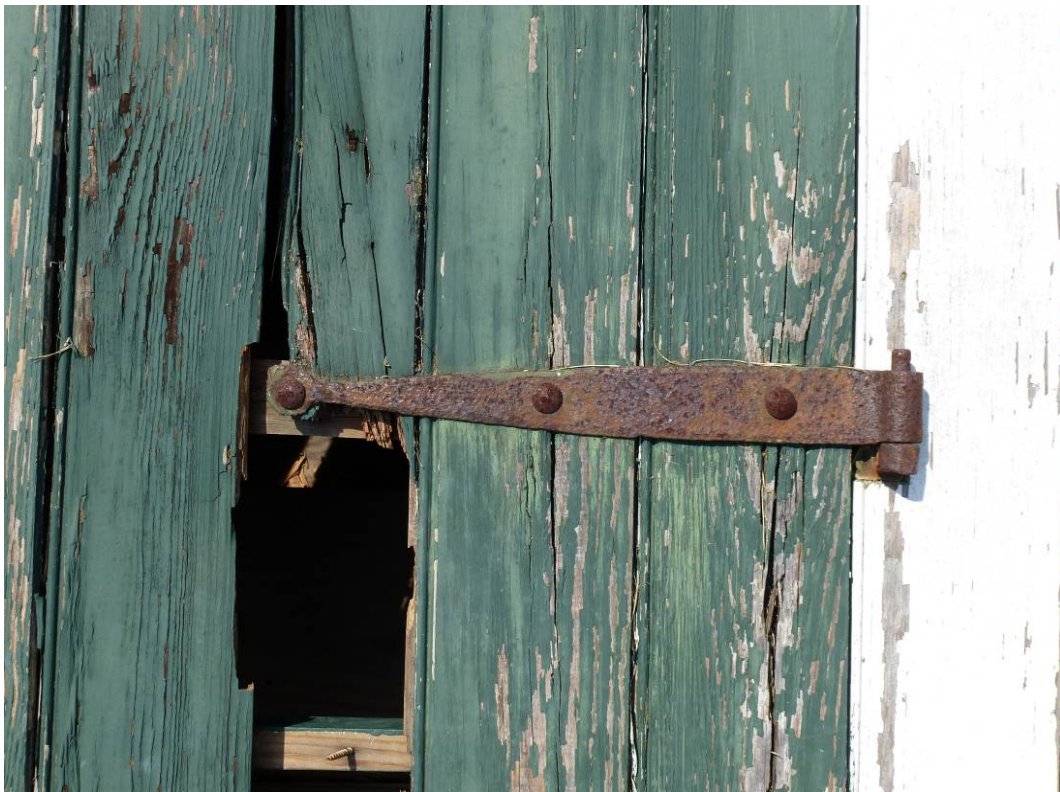
Figure 131. Door hinge on wood cellar door. Whenever the doors are replaced, the hardware should either be repaired or replaced in-kind (ERDC-CERL, 2012).

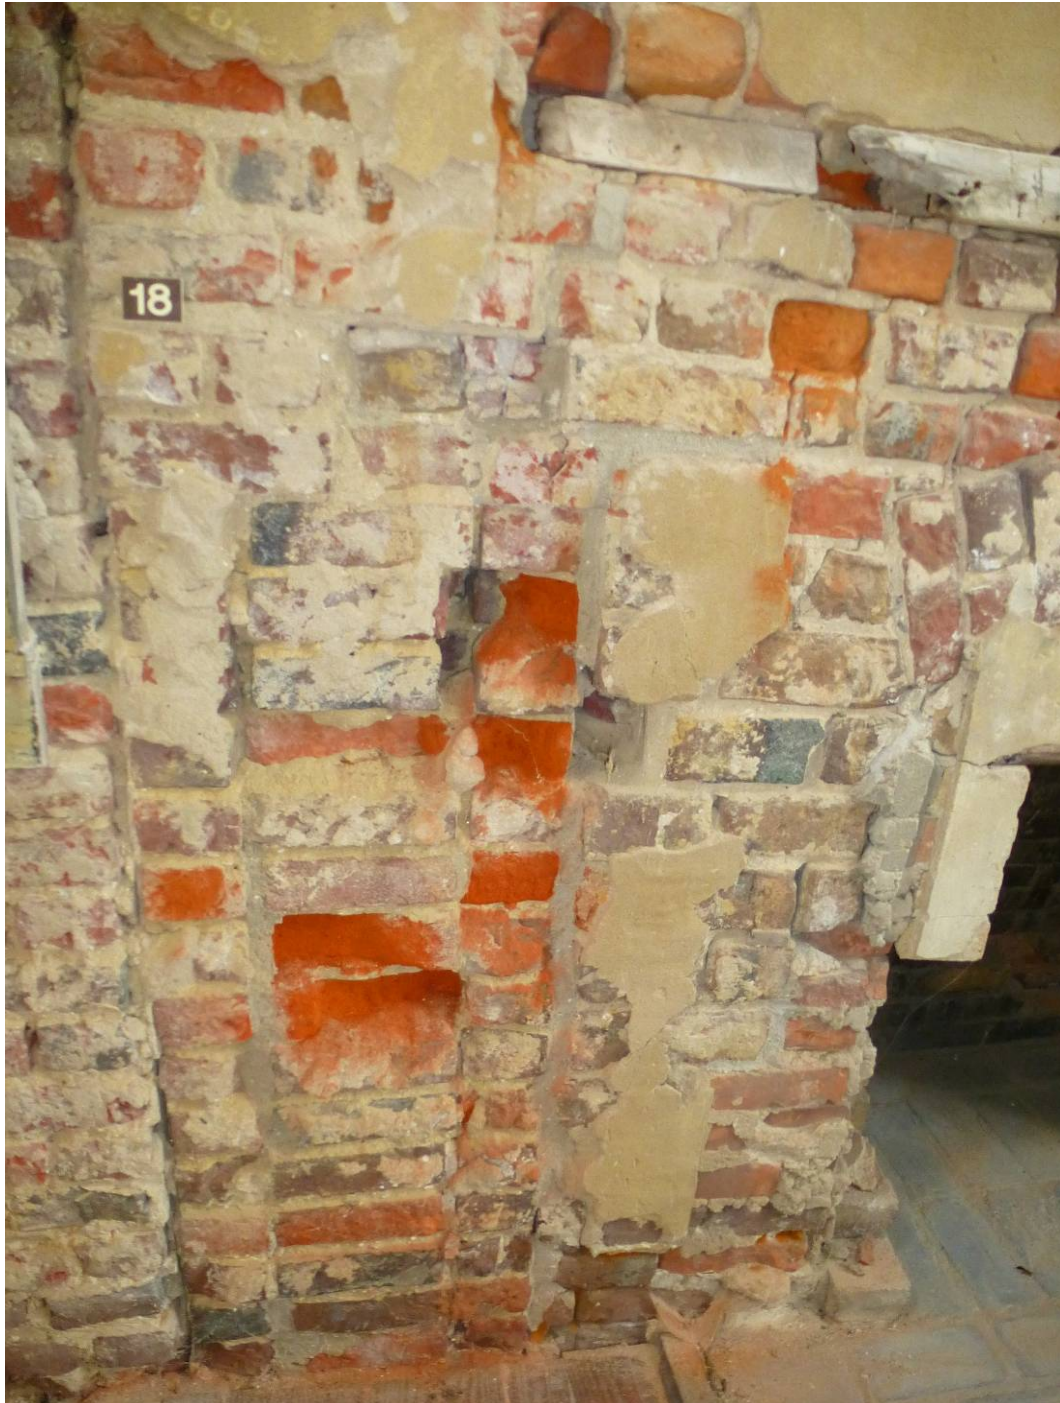
Figure 134. Joint with brick wall showing the brick infill used to make the original large hall fireplace smaller. Also note the deterioration of the brick in the west fireplace (ERDC-CERL, 2012).

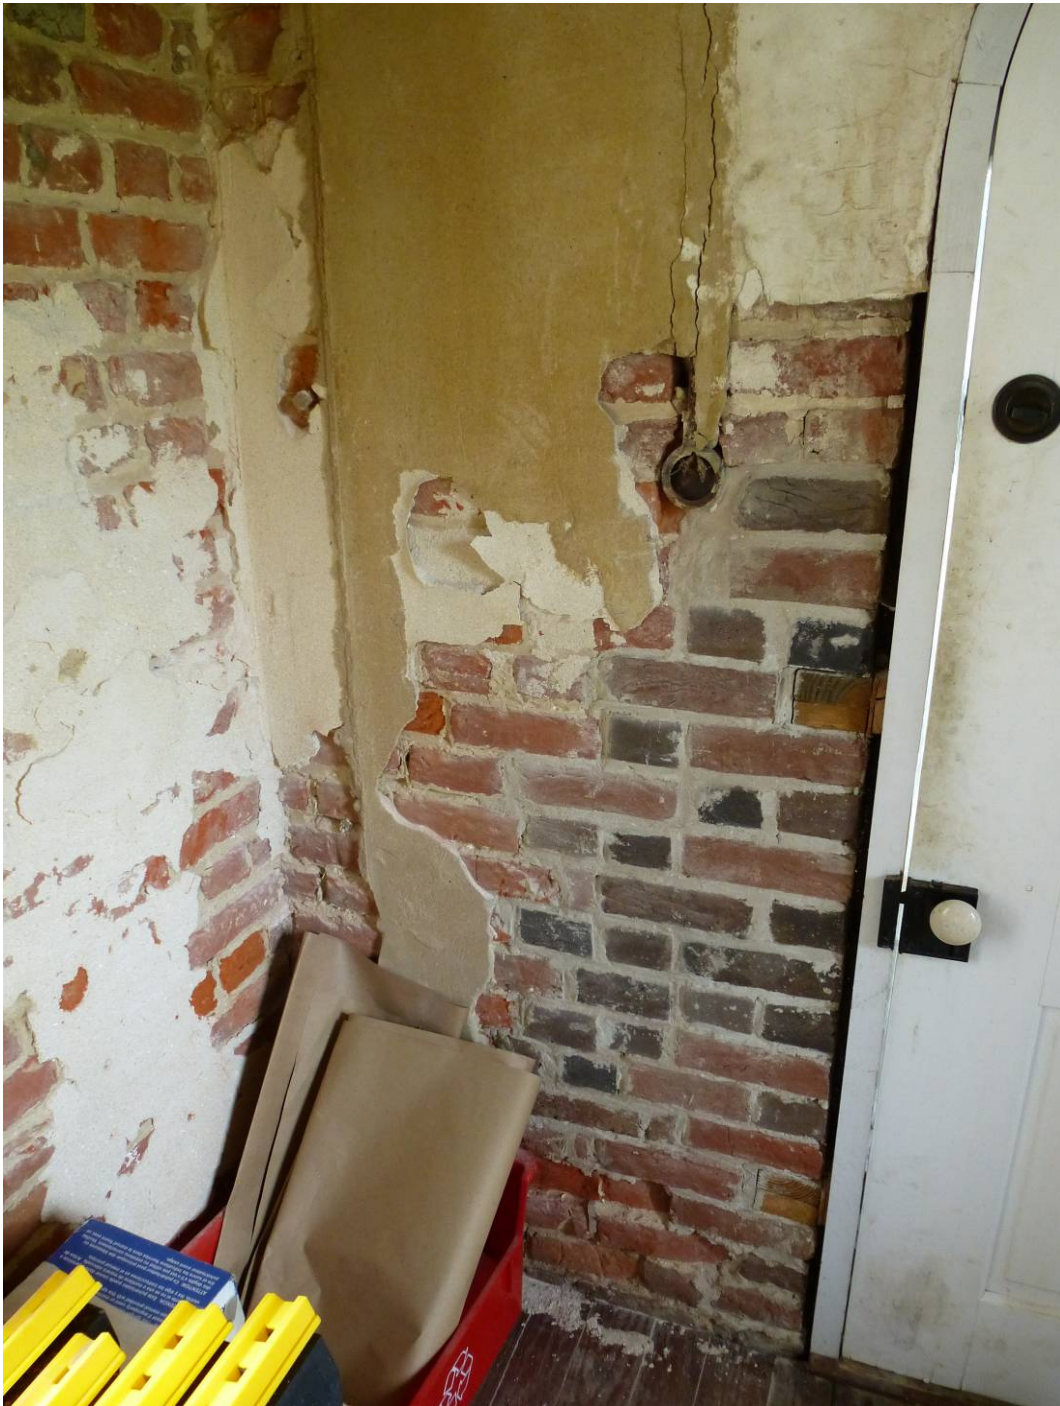
Figure 148. Northeast brick wall of porch tower with failing plaster work (ERDC-CERL, 2012).

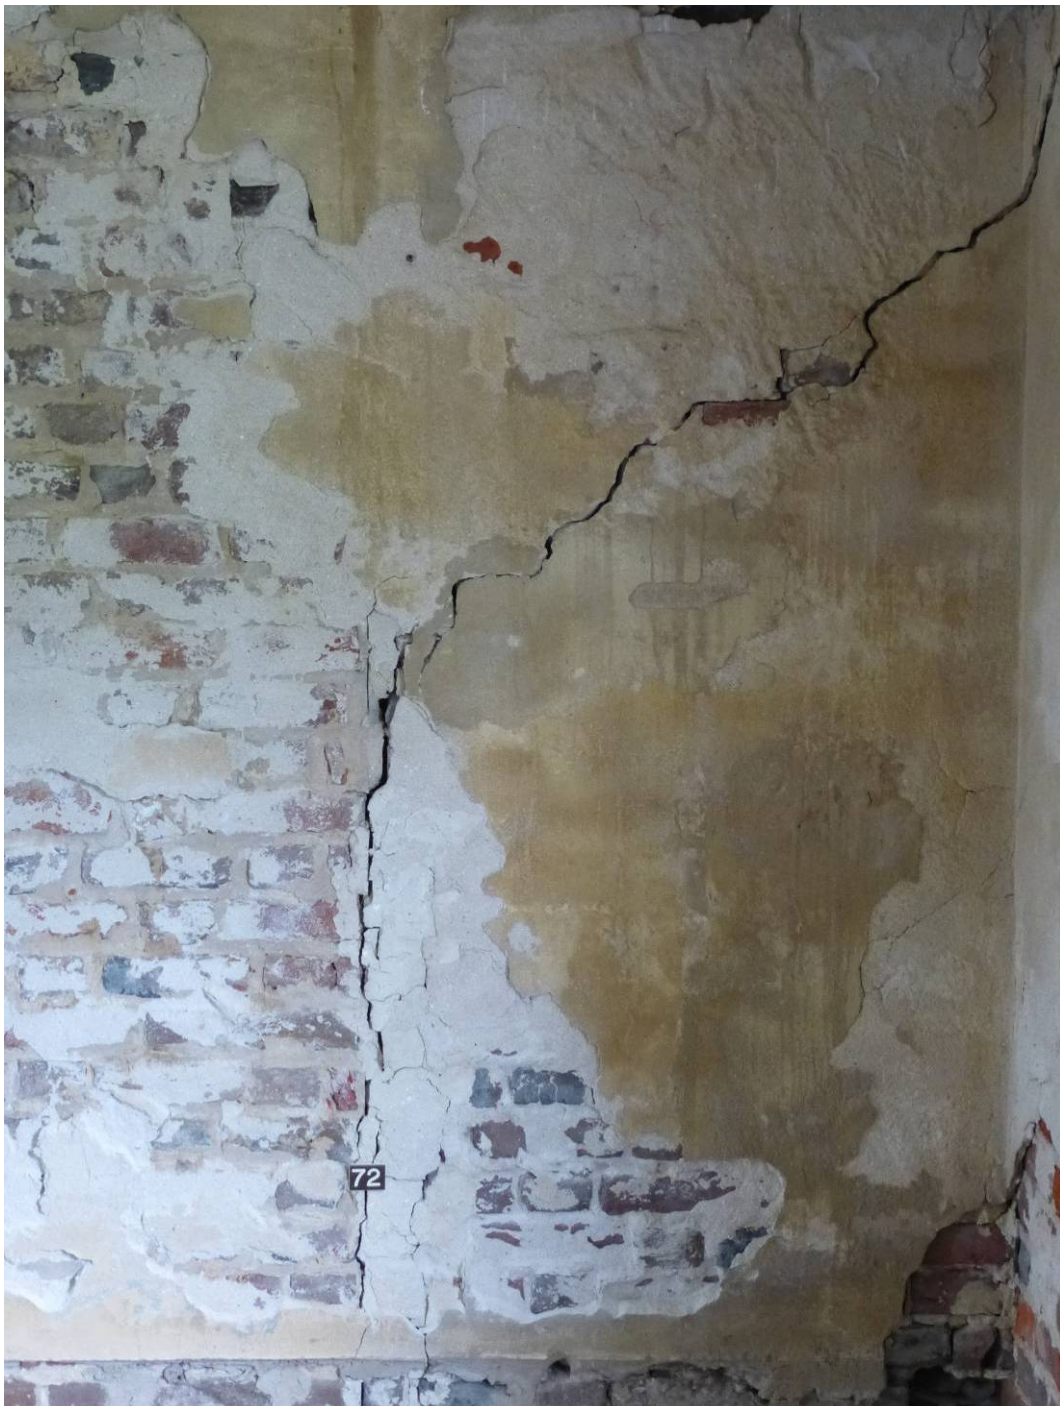
Figure 153. The knee-wall studs on the northwest wall caused vertical cracks not only in the plaster but also in the brick wall (ERDC-CERL, 2012).

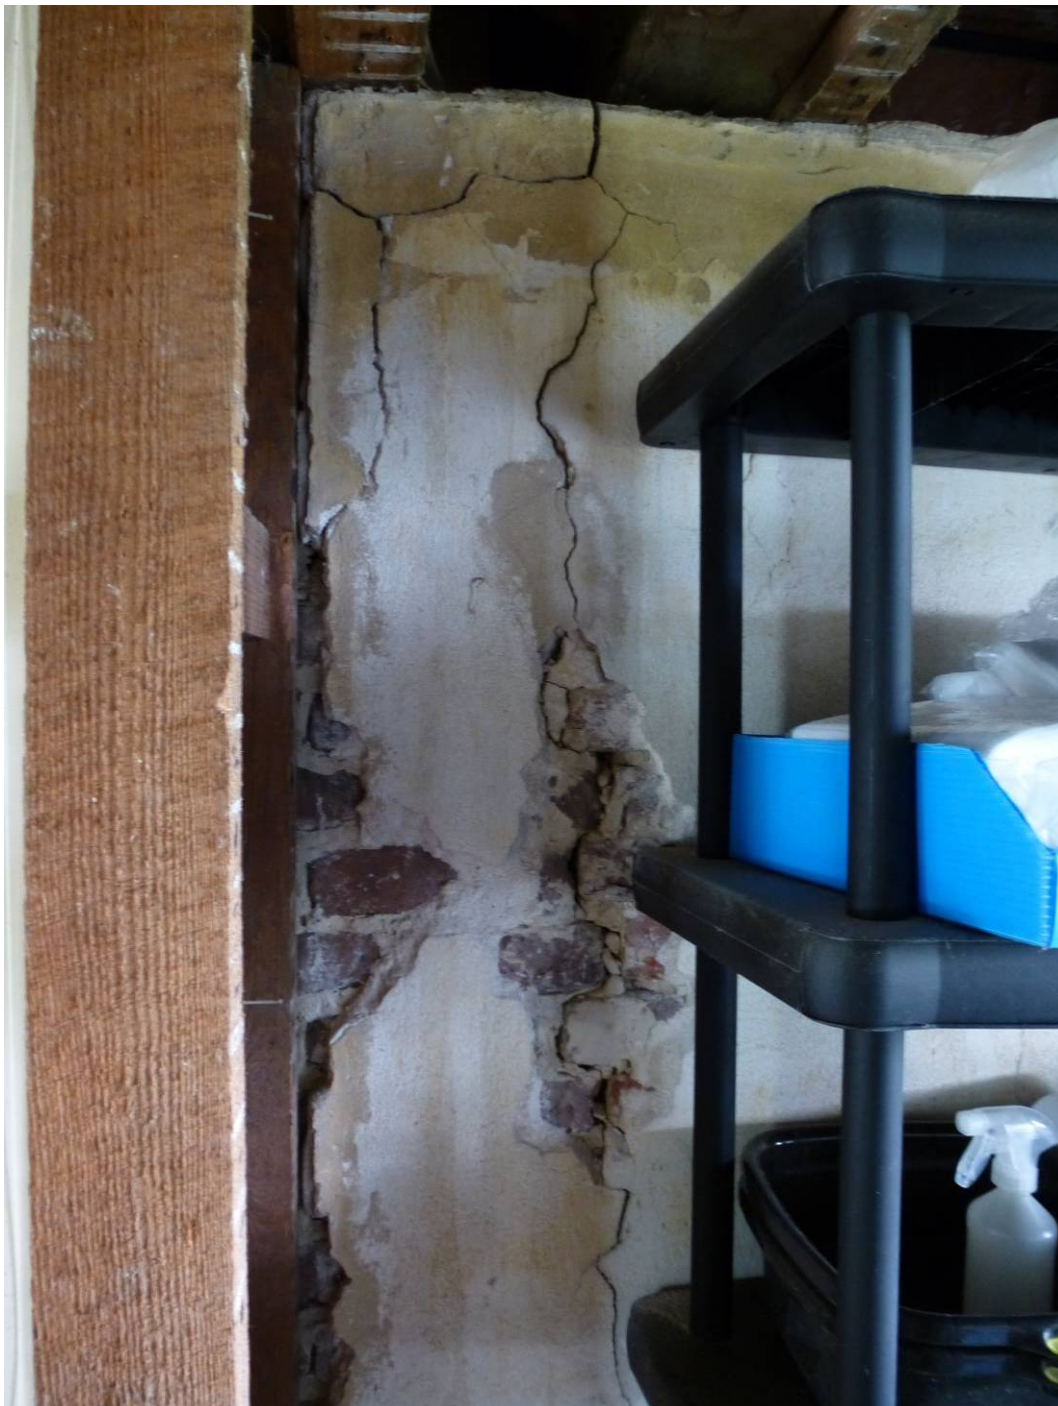
Figure 154. Second-floor southeast wall of porch tower is showing signs of cracking in both plaster lath and brick exterior wall (ERDC-CERL, 2012).

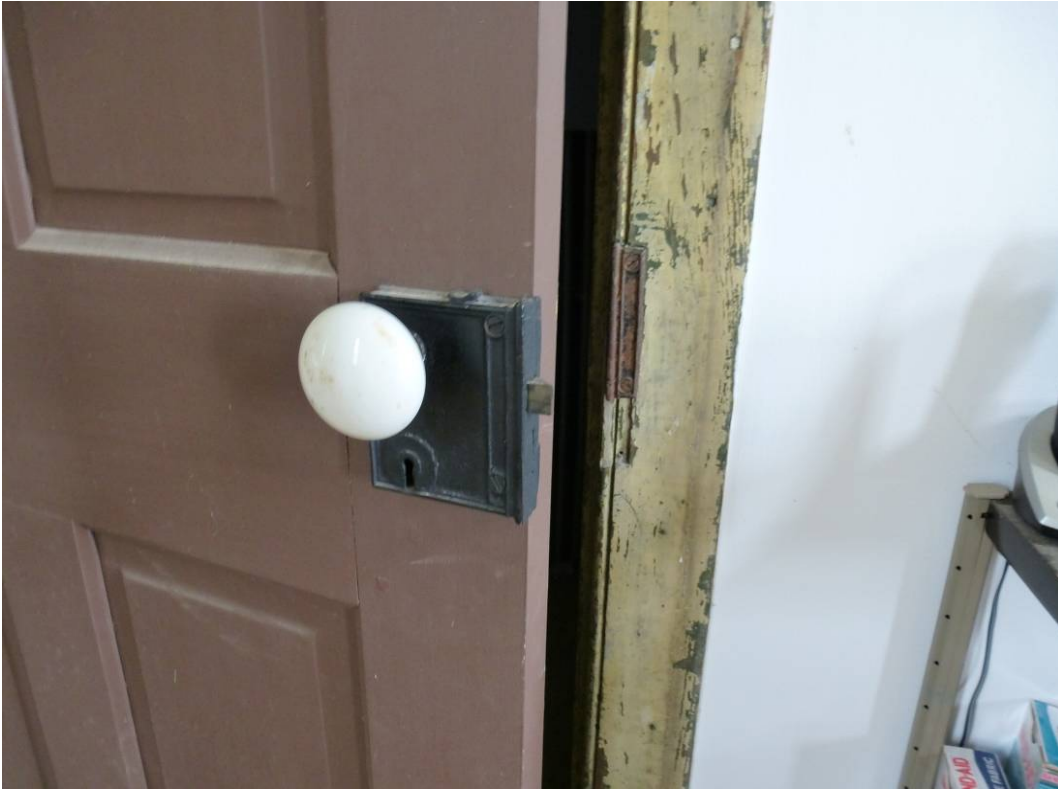
Figure 183. Rusty door hinge (ERDC-CERL, 2012).

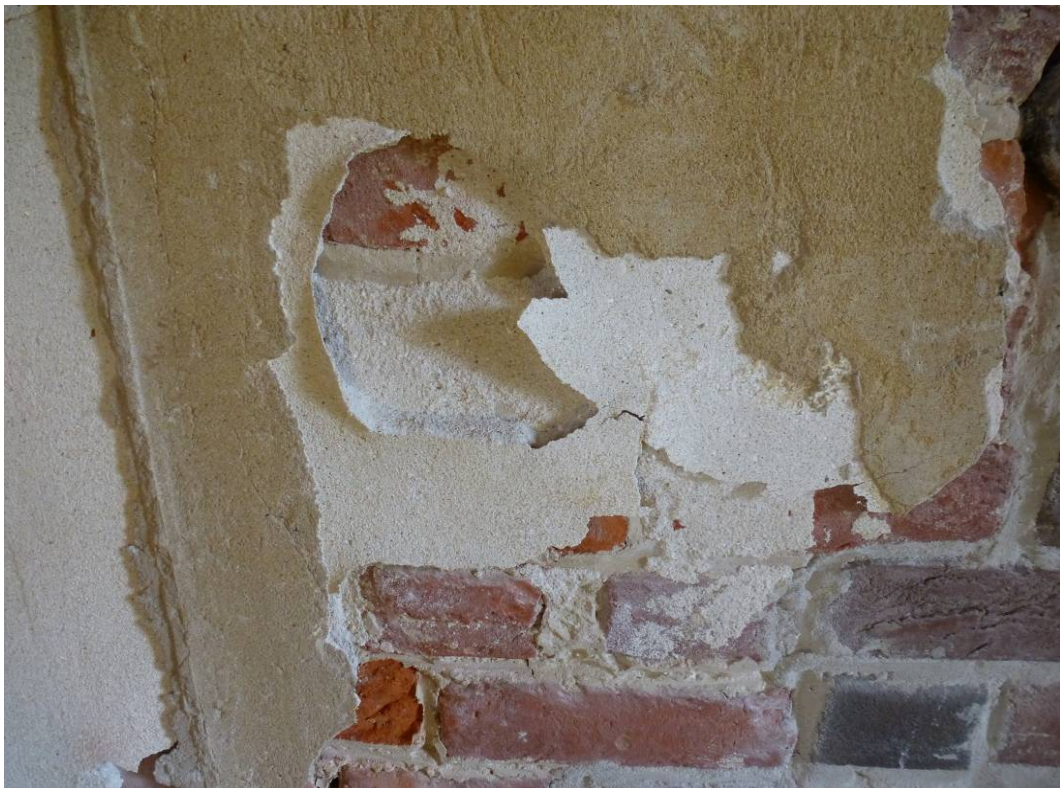
Figure 189. Plaster has fallen off the top half of the brick wall (ERDC-CERL, 2012).

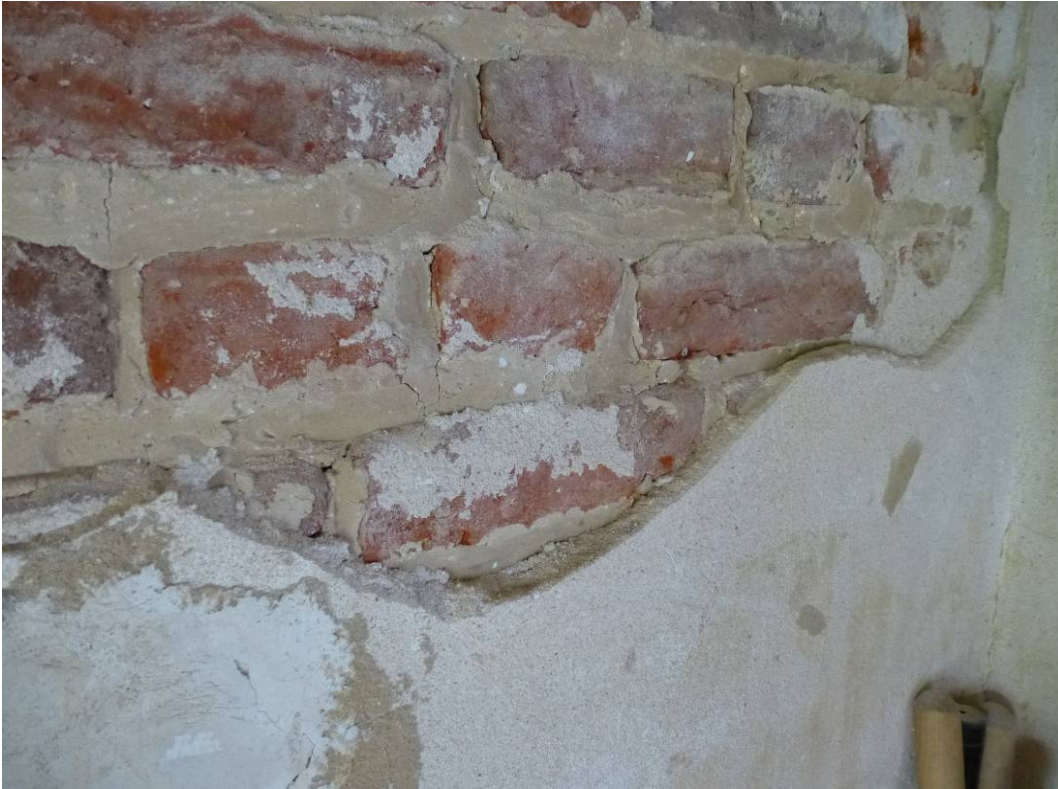
Figure 190. Here there are cracks in plaster wall (ERDC-CERL, 2012).

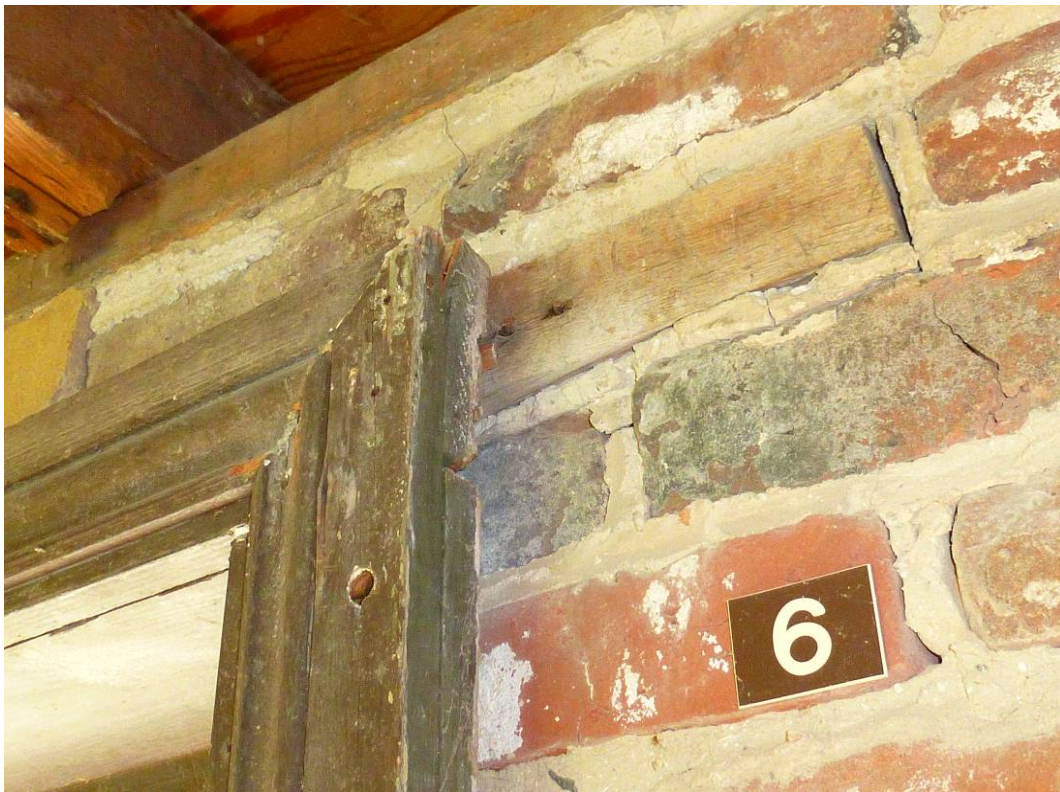
Figure 206. Paint is failing on the wood window trim (ERDC-CERL, 2012).

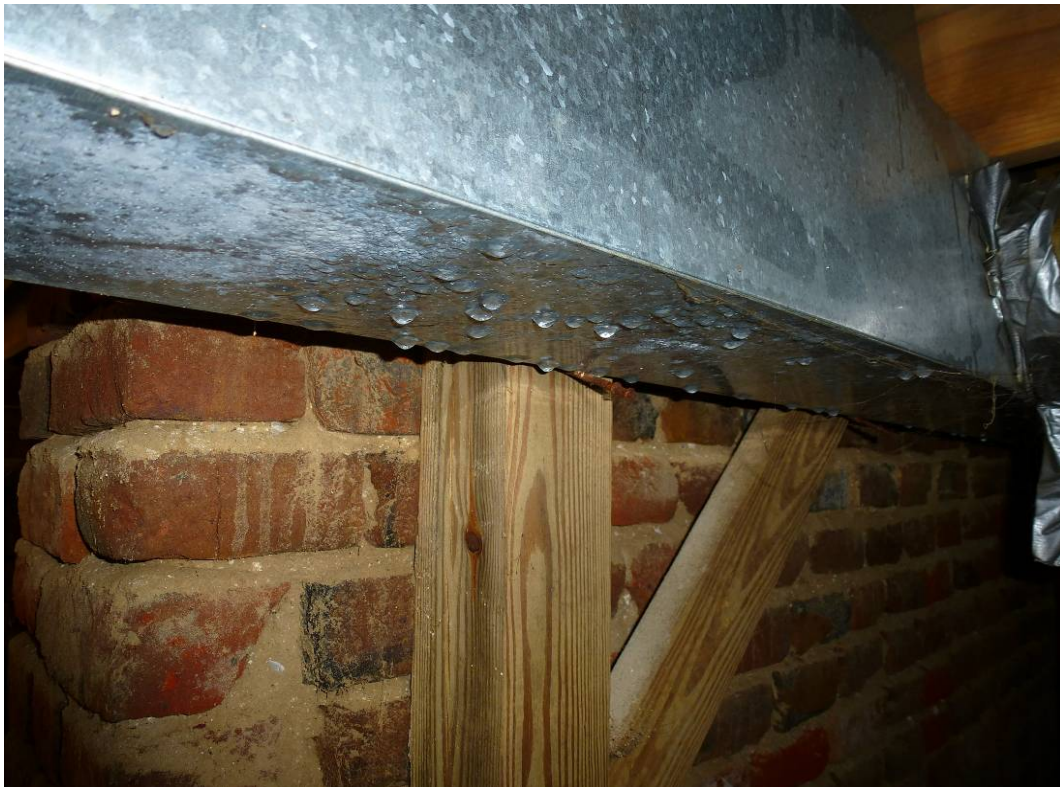
Figure 216. Either water from the ground or condensation from the HVAC system is damaging the brick cellar wall; damage is evident from the white appearance of the brick (ERDC-CERL, 2012).

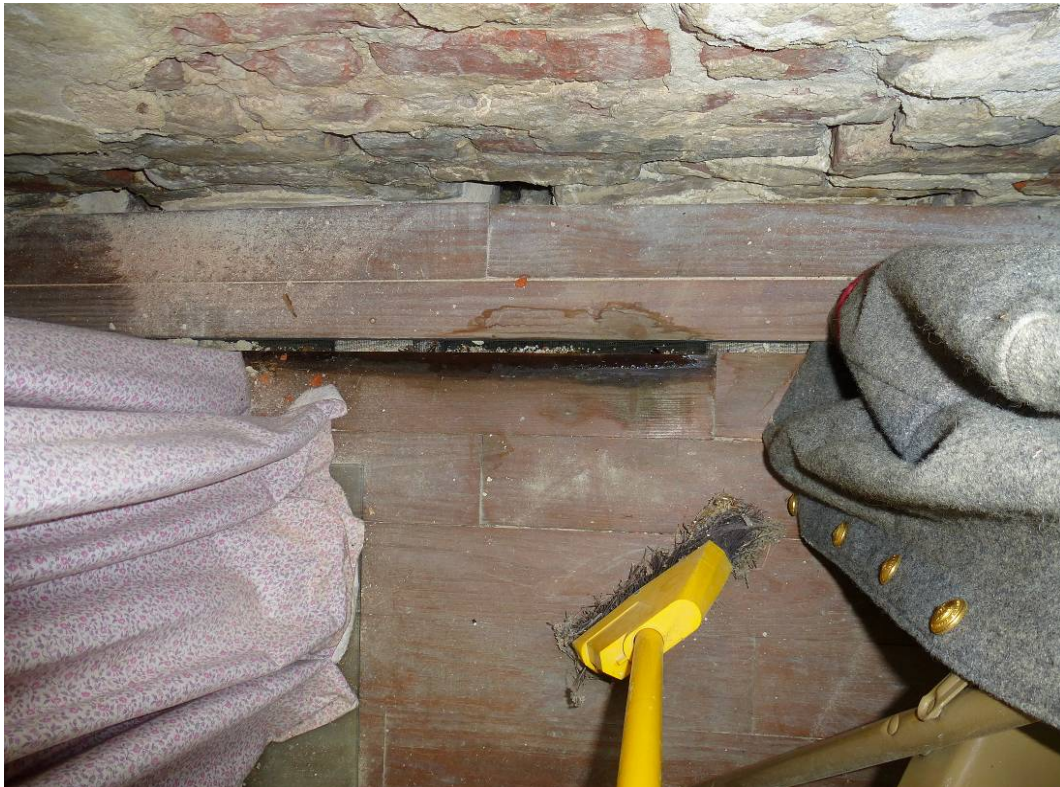
Figure 220. Cabinet should be moved off of the slit vent in the floorboard (ERDC-CERL, 2012).
